# Manhole Inspection Summary

Manhole # S41A\_\_034MH

Insp Date: **7/18/08 8:46 AM**

**Location** Address: **528 mcelderry st**

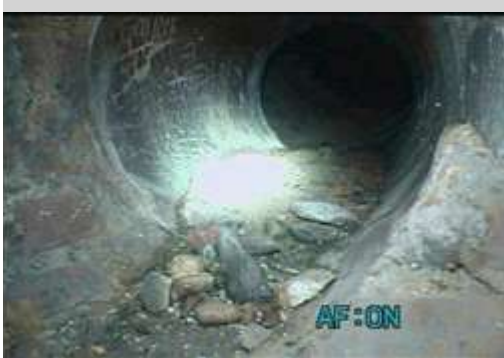
Defect 2

Condition: ☐ Sound ☐ Cracked ☐ Root Intrusion ☐ Deteriorated ☐ Leaks ☒ **Debris**

Count: **2** Missing: **0** ☒ **Corroded**

& steps

channel debris

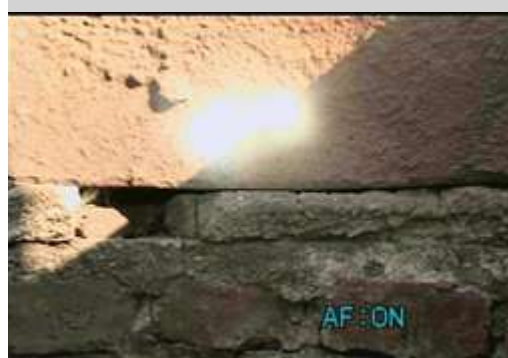
Defect 1

Condition: ☐ Sound ☒ **Cracked** ☐ Root Intrusion ☐ Loose Brick ☒ **Deteriorated**

Infiltration: ☐ None ☐ Joint ☒ **Cracks** ☐ Mortar ☐ Roots ☐ Wall

Cracked and Deteriorated Chimney,  
Infiltration

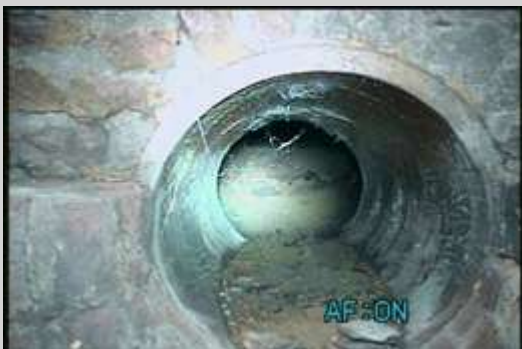
3 O'Clock Inflow

10 in. Circular Gravity Sewer  
Pipe In @ 3 O'Clock

Deposits: ☐ None ☐ Mud ☐ Sludge ☒ **Debris** ☐ Grease

Silt Depth: 2 (in.) Deposits Extent: **Light**
